Geophysical Exploration of Buried Glass Hotspots

Report on Electrical Resistivity Tomography (ERT) Survey at Bergdala and Strömbergshyttan Glass Dumps

Client: Ragn-Sells Group

Date: 2020-08-25

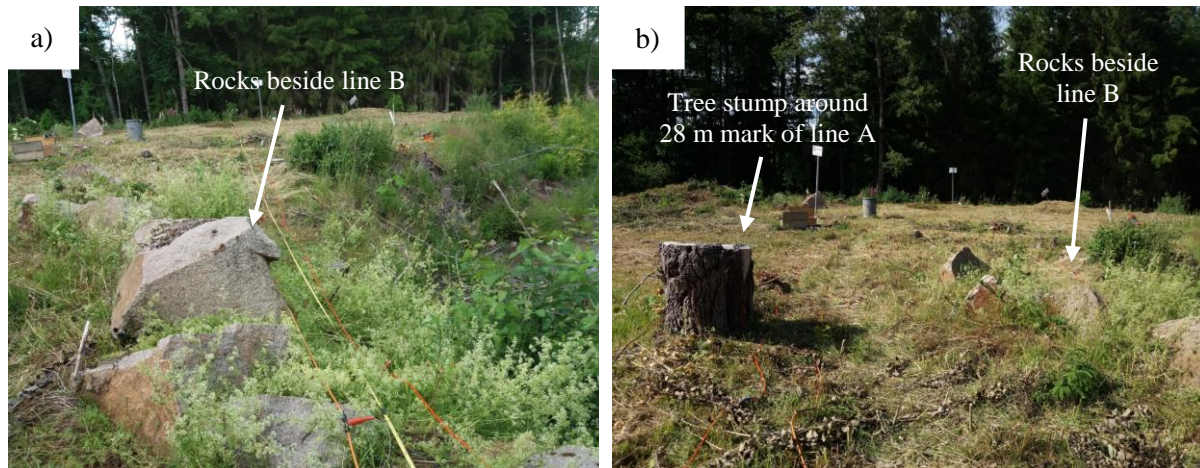
Figure 6. Features contributing to resistivity contrasts in ERT profiles; (a) big rocks besides line B, and (b) tree stump and more rocks along lines A and B, respectively.

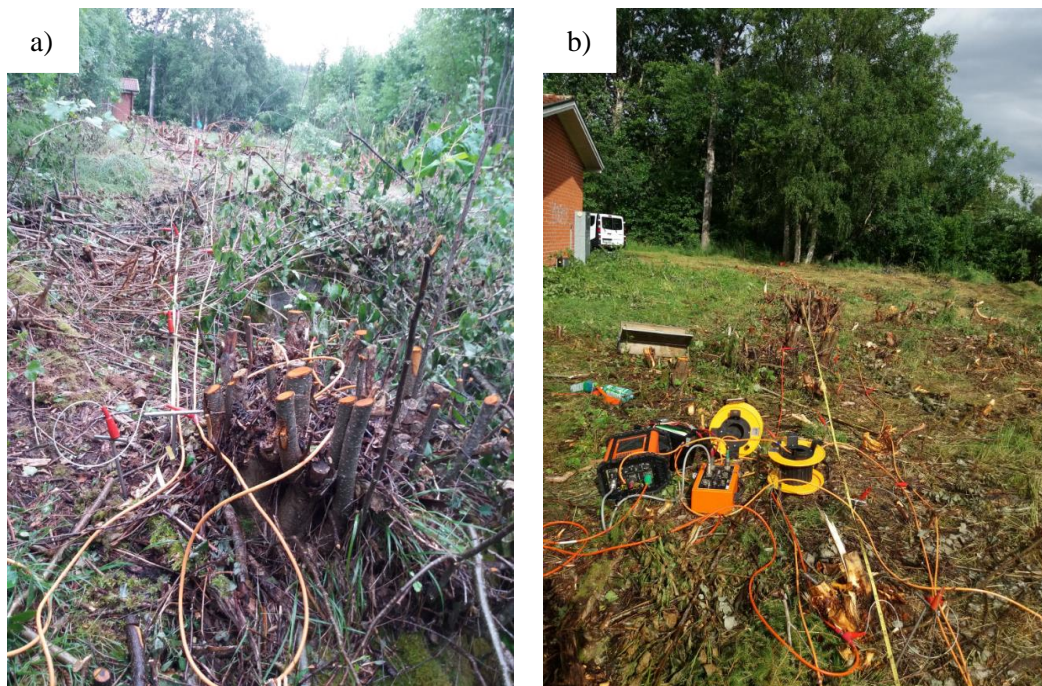
Figure 10. Cleared area with tree stumps along the survey line. (a) Beginning of the line, near the stream on the western part, and (b) around the middle of the line, eastward.
